THERMAL IMAGING REPORT

**Any Street
Any Town , NJ**

**PREPARED BY
LHI ANALYTICAL**

Report: 0006719

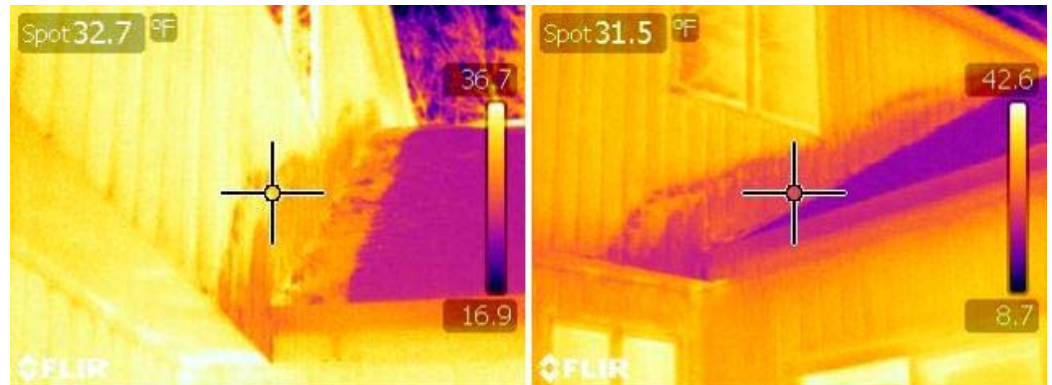
Moisture is soaking into the rear siding. Recommend diverting rain water from the upper roof.

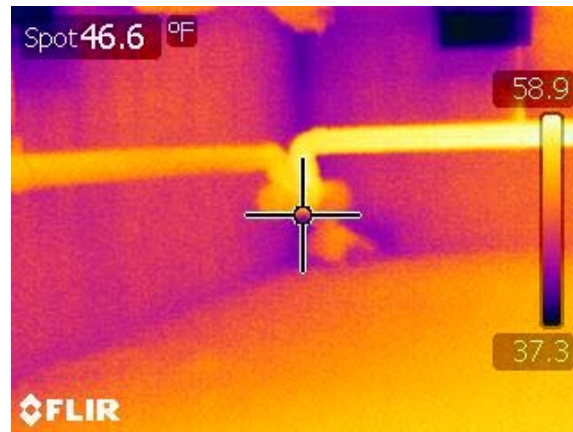
Moisture stains were noted in the crawl area; around the rear septic pipe.

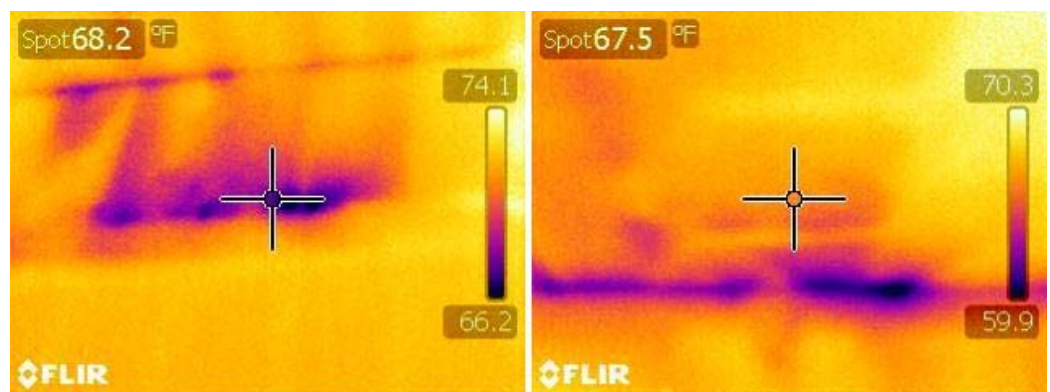
PHOTO

Missing insulation was noted along the top of the wall on the staircase and above the master bedroom door.

Missing insulation was noted along the top of the wall on the staircase.

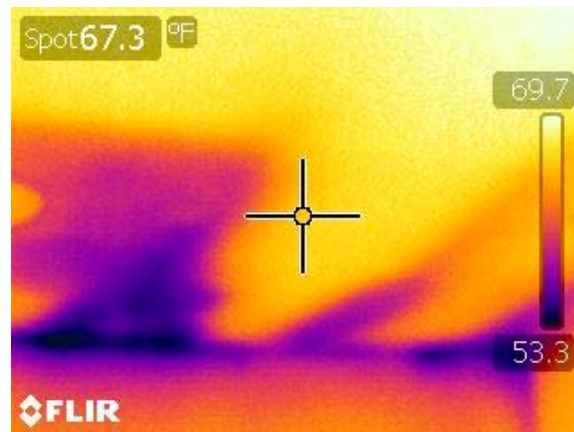
PHOTO

Missing insulation was noted above the master bathroom.

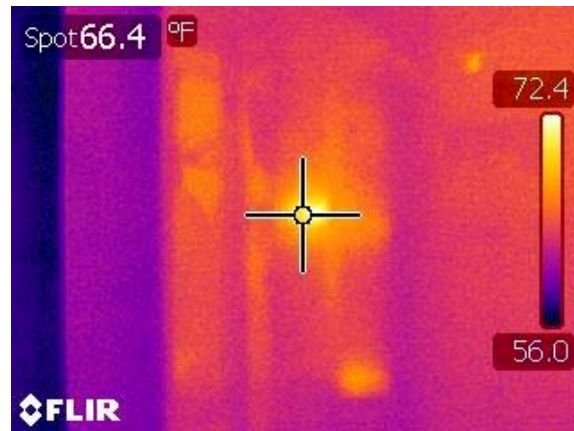
Located in the basement. Appears to be in serviceable condition. No evidence of overheating was noted in the panel.

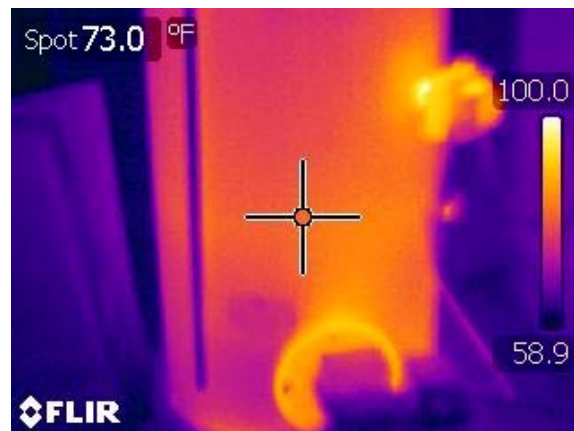
No evidence of overheating or leaking.

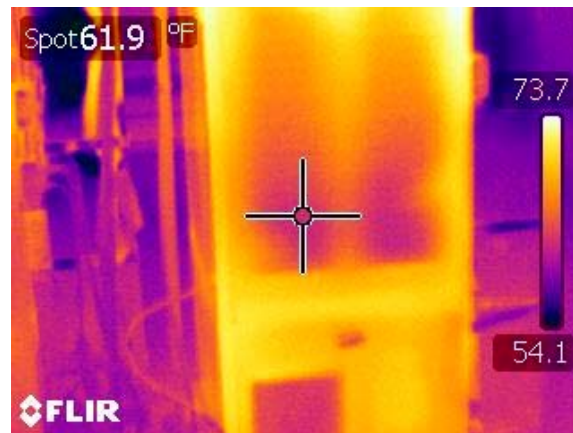
System was operational when tested. No evidence of overheating.
