PREPARED BY LEWIS HOME INSPECTION INC.

### Sample Report

Report: 0004550

Re: 400 River Blvd, Any town, Any state, 08015

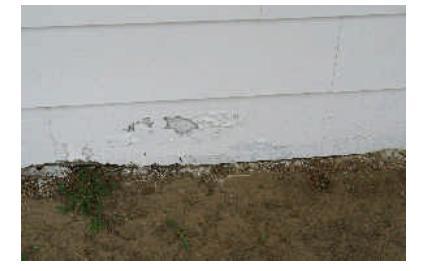
Damage was noted on the front siding.

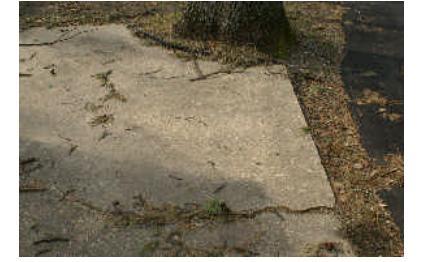
The surface has raised/settled which presents a hazard.

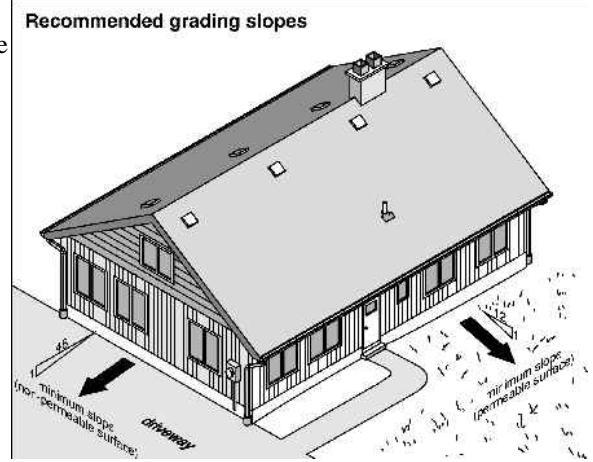
The site is noted to be flat. Lower soil below siding. Grade should be 6 inches below any wood materials.

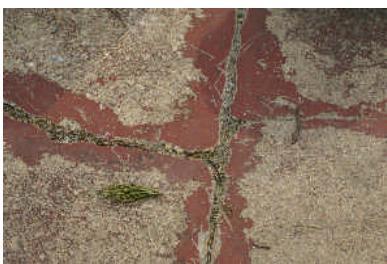
The cracks noted are considered major. The surface has raised/settled which has resulted in a hazard.

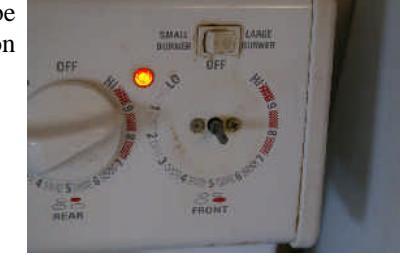
Electric, Free-standing, Tested and appears to be in serviceable condition. Control was missing on the stove.

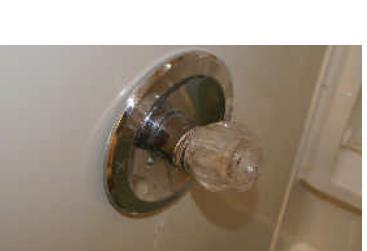
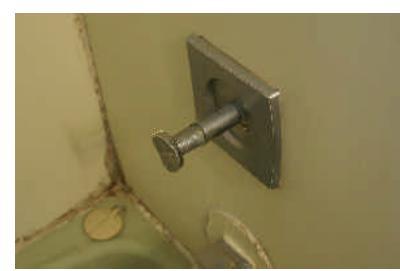
Minor leakage is noted at faucet handles in the master bathroom. The following problems were noted at the tub/shower drain: Mechanical drain stopper is not operational at tub. Shower head appears serviceable.

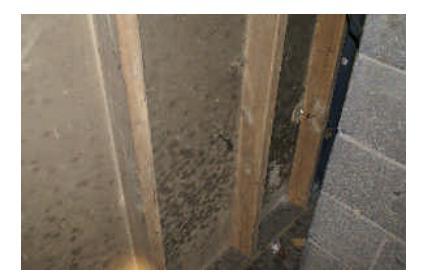
Mold was detected in the home. Recommend further testing to quantify the type of mold and the hazard to the environment. Staining was noted: in the basement. Wall board requires removal.

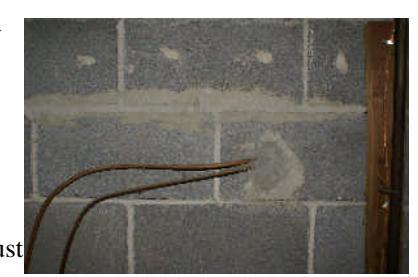
Oil, Oil tank appears abandoned. Make inquiry with the seller. It is suspected that an underground oil storage tank exists on the property. According to the Environmental Protection Agency(EPA), this situation can represent a significant environmental risk. In most cases these tanks eventually must be removed. Contaminated soil around the tank must be removed. The cost for this work can be

## substantial. We recommend you test the tank prior to purchase. 100,000.

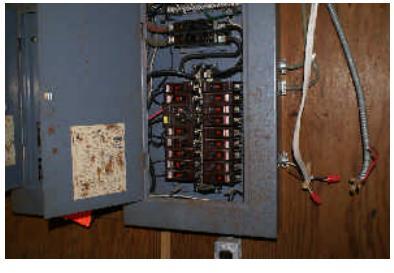
Circuit and wire sizing correct so far as visible. Grounding system is properly installed. Missing cover was noted on the main panel. Have a licensed electrician make further evaluation and corrections as needed.

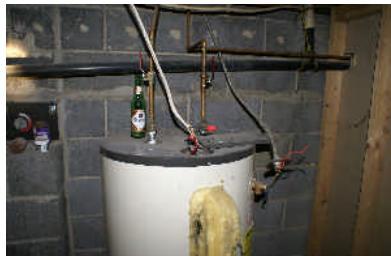
Exposed wiring was noted on the water heater. Pressure relief valve drain line is missing or ends prematurely. This is a SAFETY HAZARD. We recommend this drain line be extended to a safe location.
