PREPARED BY LEWIS HOME INSPECTION INC.

### Sample Report

Report: 0004550

Re: 400 River Blvd, Any town, Any state, 08015

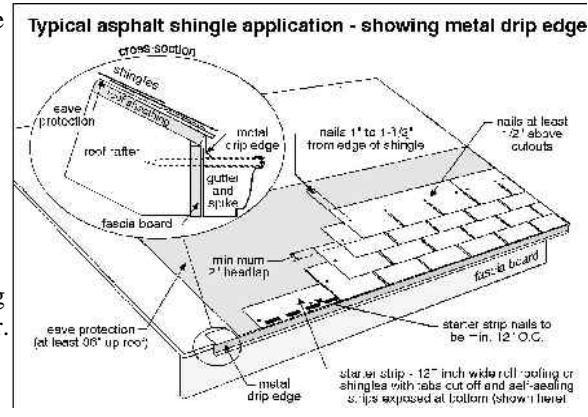
#### Gable.

Composition shingles are made by impregnating mats of either an organic felt material or fiberglass with asphalt and covering one surface with mineral granules. The mat is the vehicle for supporting the asphalt, which is water resistant. The granules protect the shingles from the damaging sun rays and also provide color. The average life expectancy of asphalt shingles is fifteen to twenty five years, dependent

upon preventative maintenance done by the current owner, of which we are unaware.

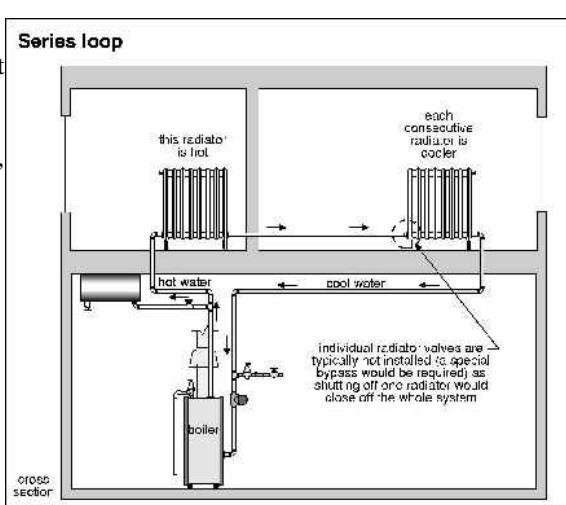
Basement.

Forced hot water boiler. The average life expectancy of a hot water boiler is thirty to fifty years. Forced hot water heating systems operate under pressure, with water being circulated by means of a pump. Several advantages of hot water boilers are:the operation is relatively quite, there is an even temperature distribution and additional zones can be added readily installed. One disadvantage is that the water in the distribution system is vulnerable to freezing

temperatures. If the home is left vacant during the winter months the thermostat should be kept on a low setting to prevent possible freezing. Service contracts which provide inspections prior to the heating season are recommended.

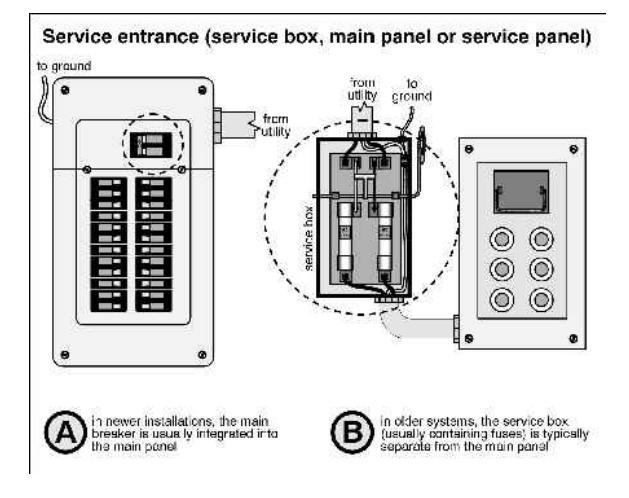
## MAIN PANEL LOCATION AND NOTES:

Appears to be in serviceable condition.

Circuit and wire sizing correct so far as visible. Grounding system is properly installed. Missing cover was noted on the main panel. Have a licensed electrician make further evaluation and corrections as needed.

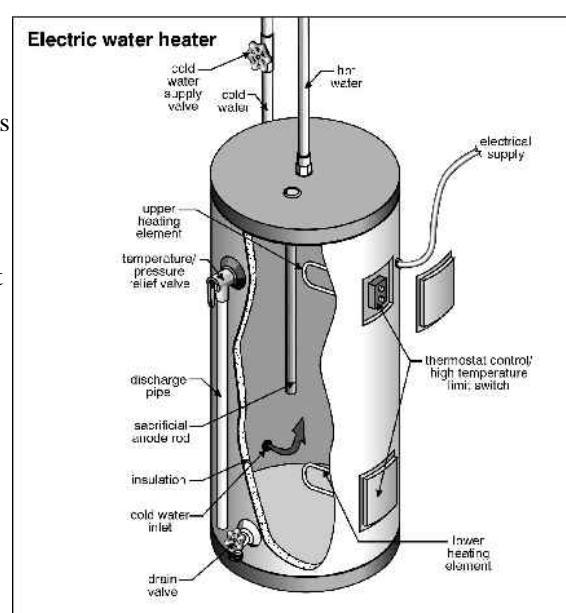
## WATER HEATER: TYPE:

Electric hot water heater. The average life of a hot water heater is eight to twelve years dependent on maintenance. It is recommended to drain about a gallon of water from the bottom of the tank every few months to flush out any sediment which accumulates at the bottom. The sediment burn off is bad for the life expectancy, efficiency and the operating noise level.
